# **Pentium® II Xeon™ Processor Specification Update**

Release Date: November 1998

Order Number: 243776-007

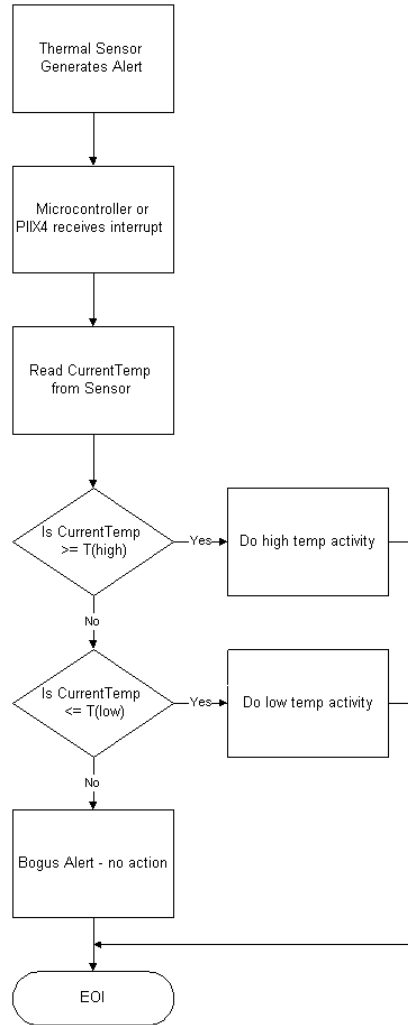
**Figure 2. Workaround Flowchart: SMBALERT#-Driven System**

### D30. Thermal Sensor May Assert SMBALERT# Incorrectly

Under the conditions described below, the thermal sensor incorrectly generates the SMBALERT# interrupt. *All* of the following conditions must be met to trigger a false interrupt:

**WORKAROUND:** Three different (mutually exclusive) workarounds are possible:

1. Before servicing an interrupt from the thermal sensor, read and compare the processor thermal reading with the threshold limits ( $T_{HIGH}$  or  $T_{LOW}$ ). Figures 2 and 3 provide basic flowcharts for the implementation of this workaround in an interrupt driven system.
2. If the firmware implemented polls the Status Register only, then before taking any action, re-read the temperature register and do a comparison with the alarm threshold limits ( $T_{HIGH}$  or  $T_{LOW}$ ) to determine if the value is actually still within the temperature window.
3. Use a temperature polling scheme to monitor the processor temperature.
